Urban Stormwater BMP Performance Assessment and Cost-Benefit Analysis

Melissa Baker, Water Resource Technician
Capitol Region Watershed District, St. Paul, MN

Arlington Pascal Stormwater Improvement Project

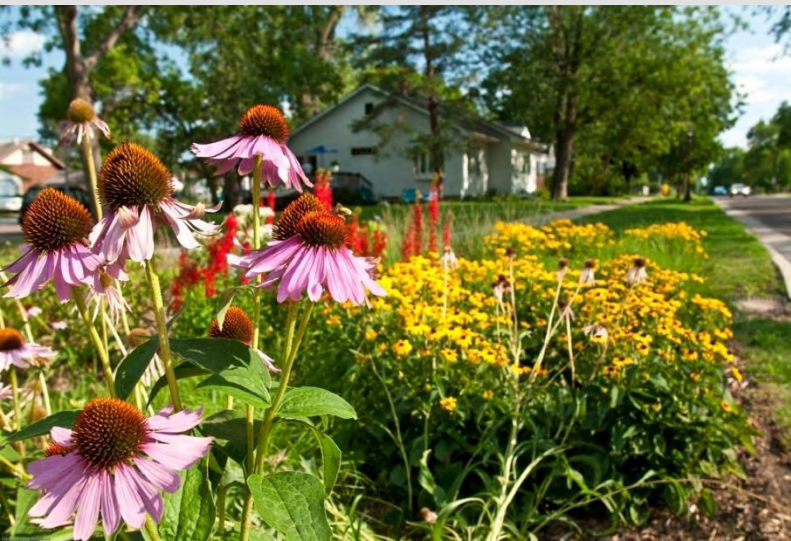
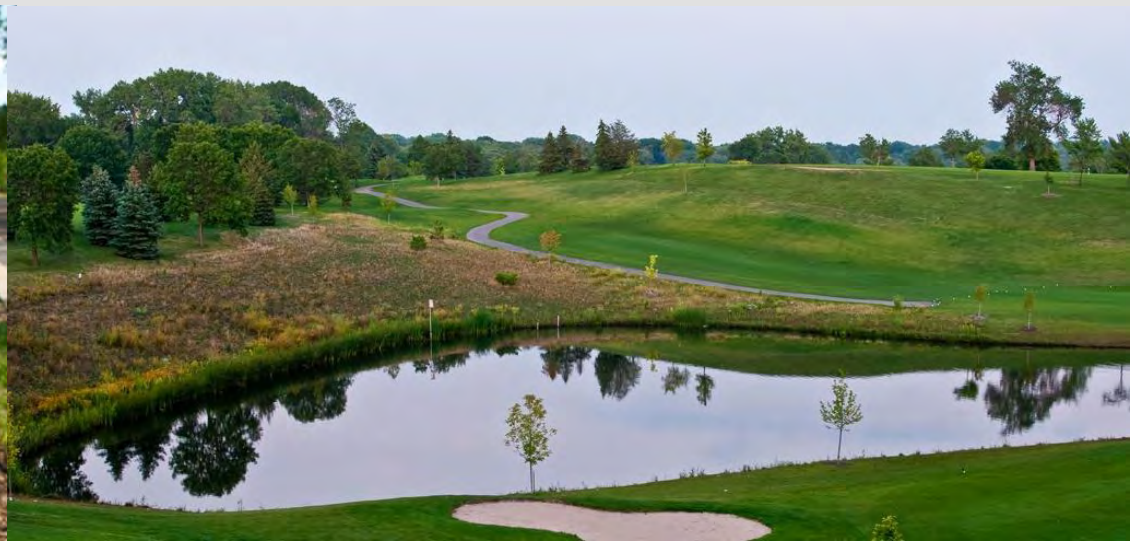
Stormwater BMPs

- Underground Stormwater Storage and Infiltration System (Arlington-Hamline Facility)
- Regional Stormwater Pond (Como Park Regional Pond)
- 8 Underground Infiltration Trenches
- 8 Rain Gardens

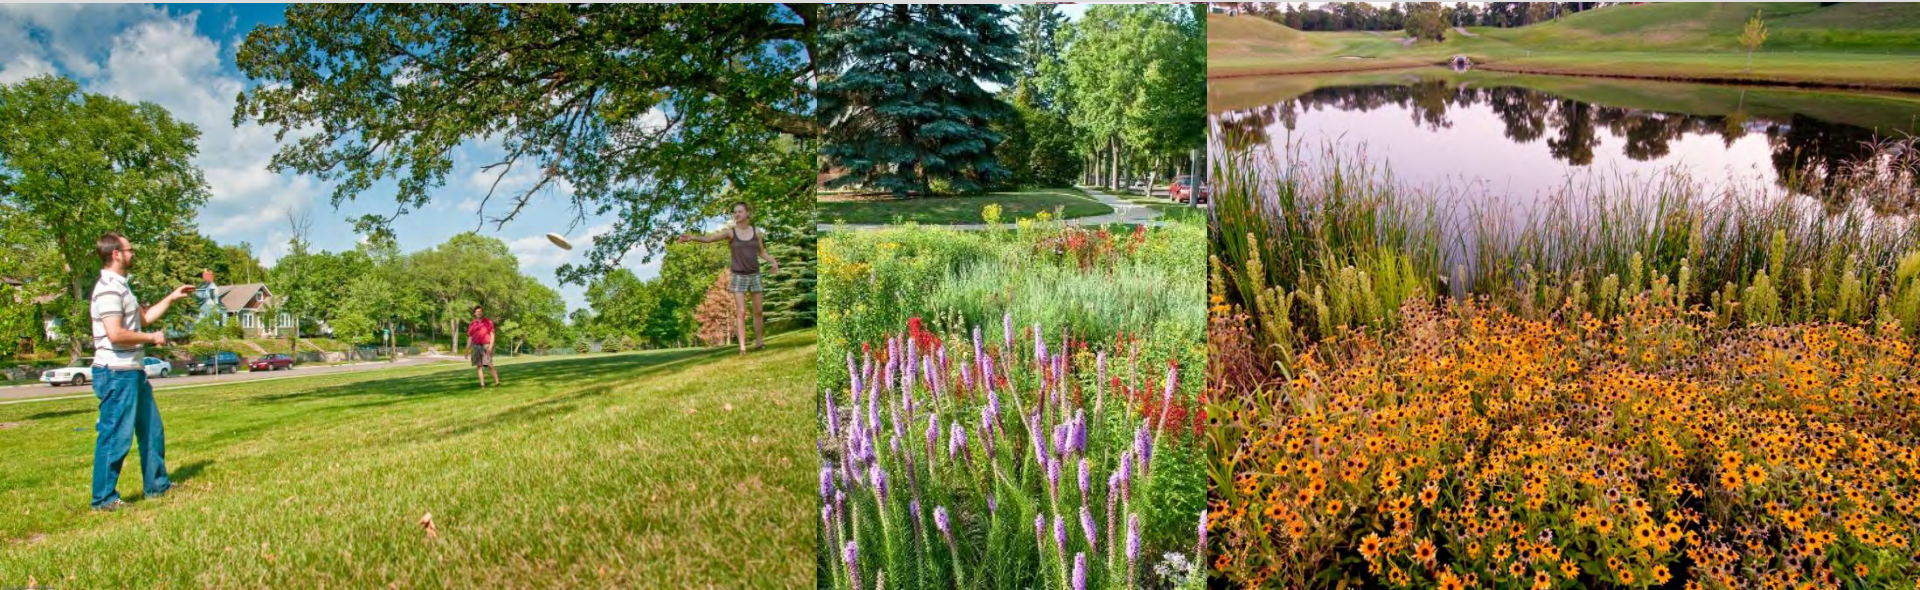
Stormwater BMPs

- Treatment Train of BMPs
- Total Drainage Area: 190 Acres
- Combined Storage Area: 142,000 ft²
- Combined Storage Volume: 444,000 cf

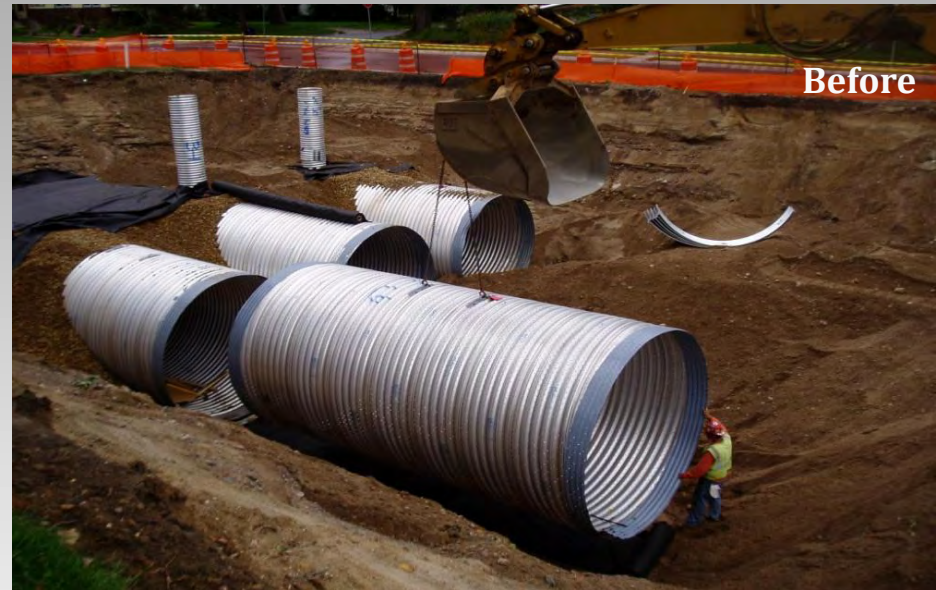
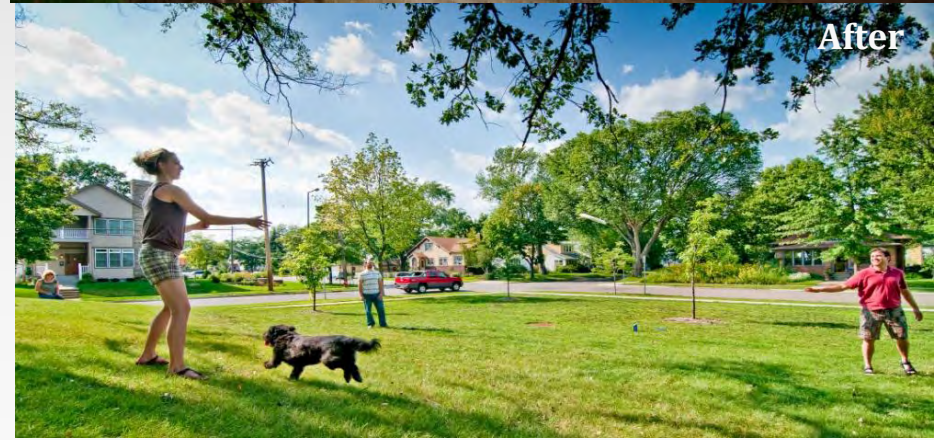
Underground Stormwater Storage and Infiltration System (Arlington-Hamline Facility)

- Total Capital Cost: \$799,000
- Storage Volume: 86,000 cf
- Drainage Area: 50 Acres
- 849 Feet of 10-Foot Diameter, Corrugated, Perforated Metal Pipes
- Vortech[®] Serves as a Pretreatment Unit
- Began Operation: Fall 2006

Arlington-Hamline Facility O&M

- Pipe Gallery Inspections
- Vortech[®] Sediment Inspections
- Manhole Sediment Inspections
- Debris Removal From Vortech[®] Unit

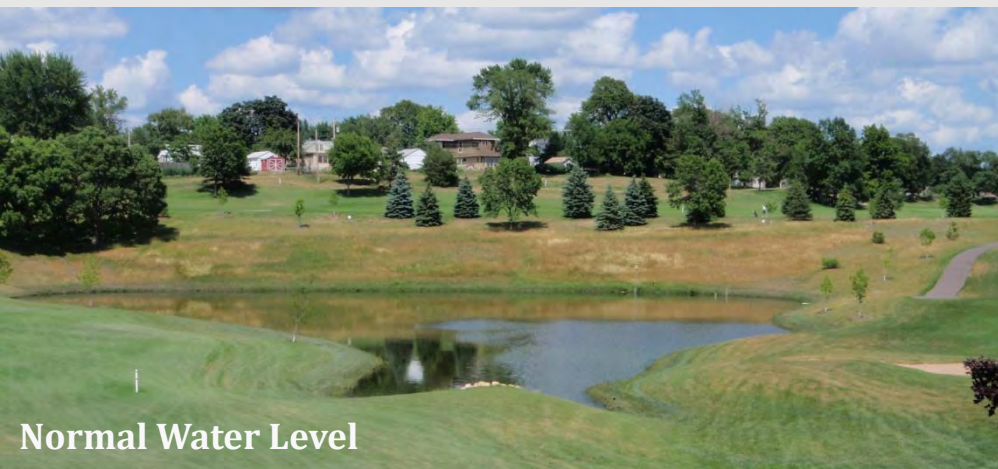
Normal Water Level

Como Park Regional Pond

- Total Capital Cost: \$1,364,000
- Storage Volume: 302,000 cf
- 128 Acres Direct Drainage Area
- **Also Receives Discharges From Gottfried's Pit in Roseville (540 Acres)**
- Began Operation: December 2007

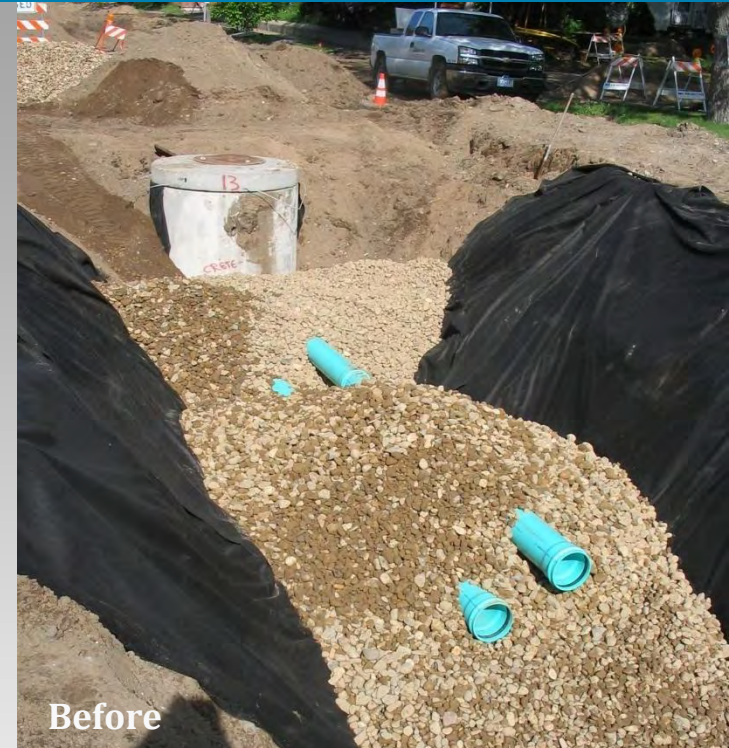
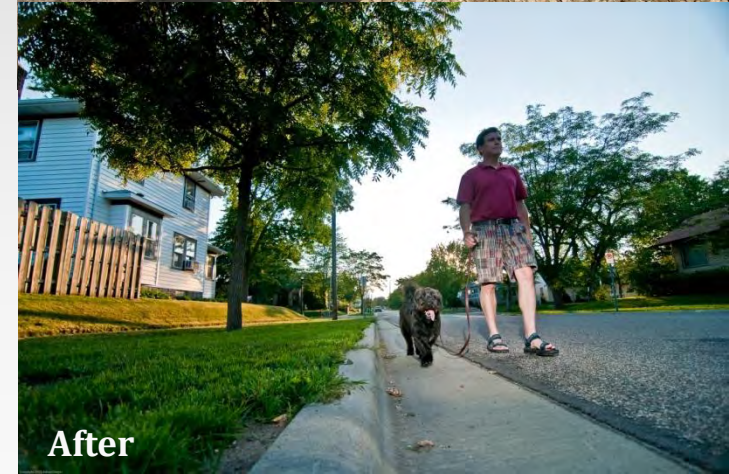
Underground Infiltration Trenches

- Total Capital Cost: \$400,000
- Combined Storage Volume: 37,000 cf
- Combined Drainage Area: 23 Acres
- Comprised of an Aggregate Backfill with 2, 10-Inch Perforated Pipes
- 30 Sumped Catch Basins and 16 Sumped Manholes
- Began Operation: June 2007

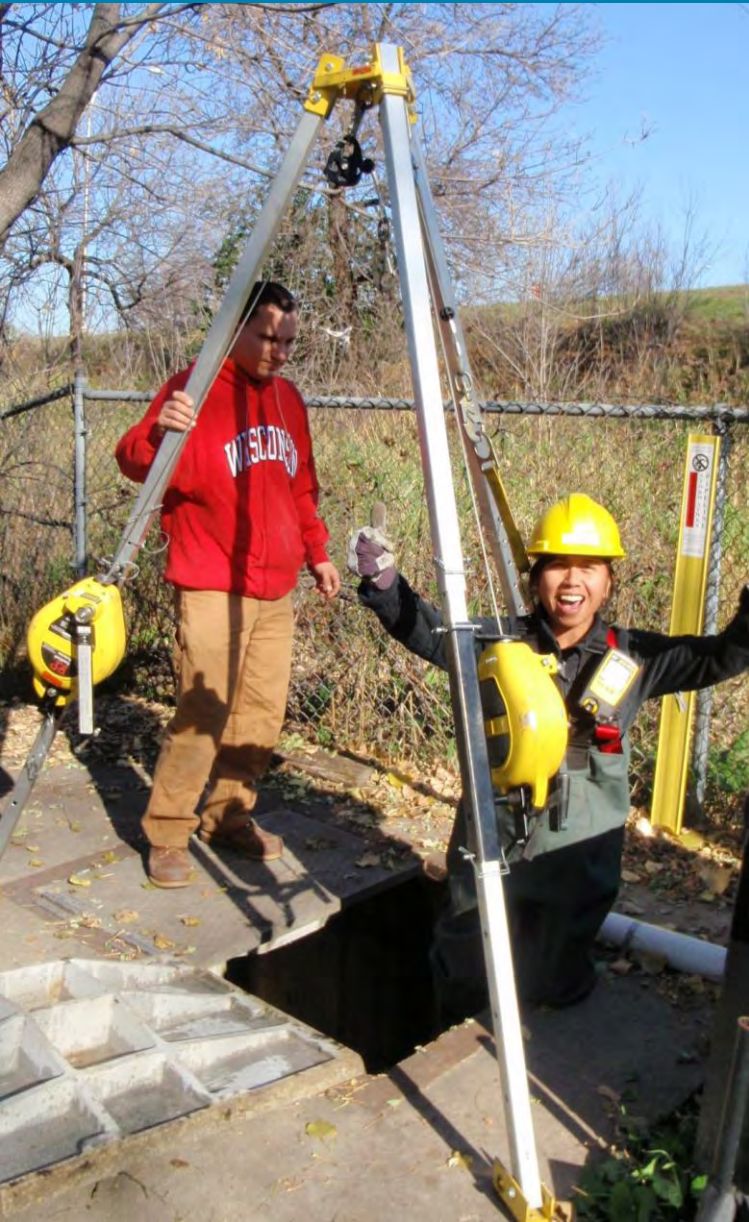
BMP Stormwater Monitoring

- Since 2007:
 - Arlington-Hamline Facility
 - 2 Infiltration Trenches (Trenches 4 and 5)
 - 8 Rain Gardens
 - Como Park Regional Pond (Monitoring Began in 2008)

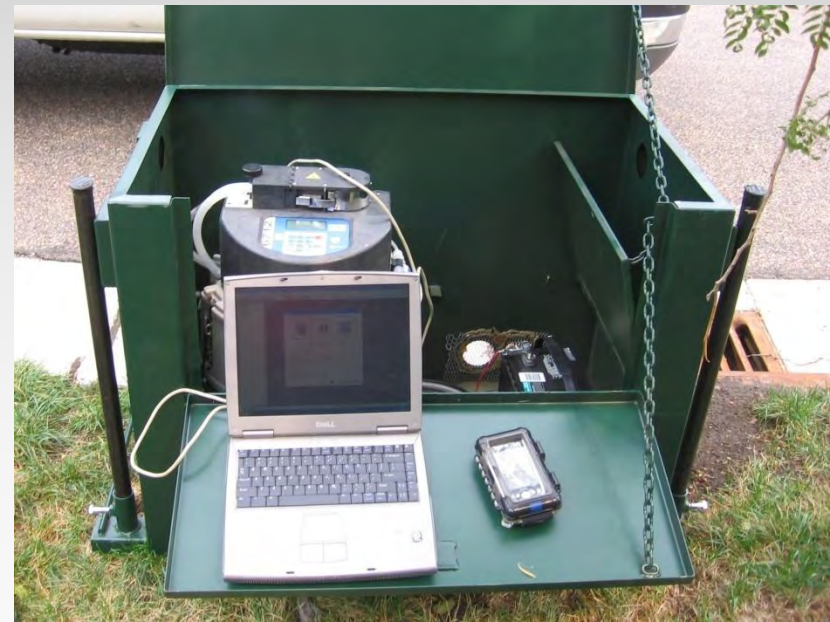
BMP Monitoring Methods

- Inlet and Outlet (except Rain Gardens)
 - Continuous Water Level and Flow Recorded
 - Water Quality Samples Collected During Storm Events
- For Each Storm Event and Monitoring Season:
 - Determined Total Flow and Calculated Total Phosphorous (TP) and Total Suspended Solids (TSS) Loads
- Also Determined Total Solids Loads Removed

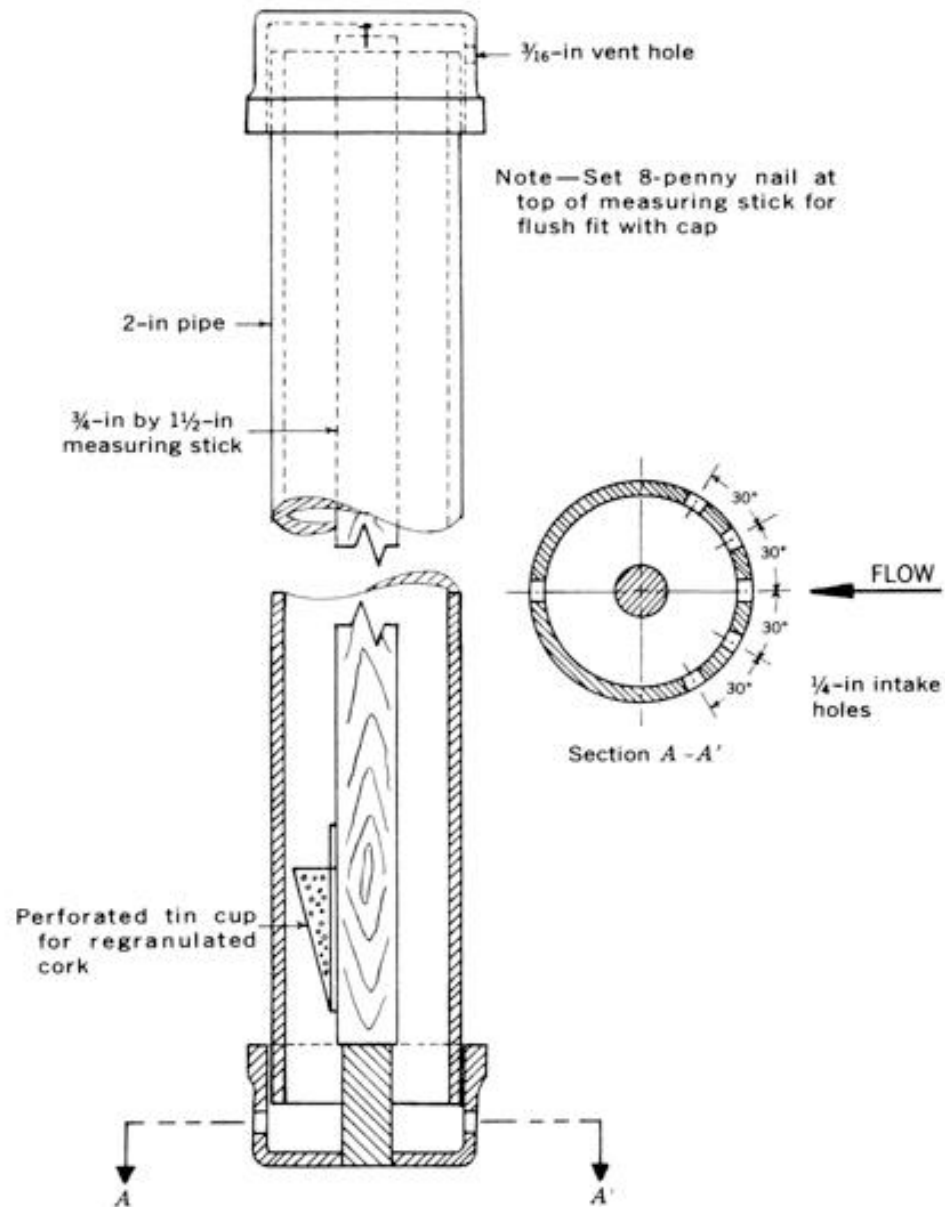
Crest Gauge

- **Manual Crest Gauges**

- **Installed at the Lowest Point in Each Garden**
- **Measured Peak Water Level Reached During a Storm Event**

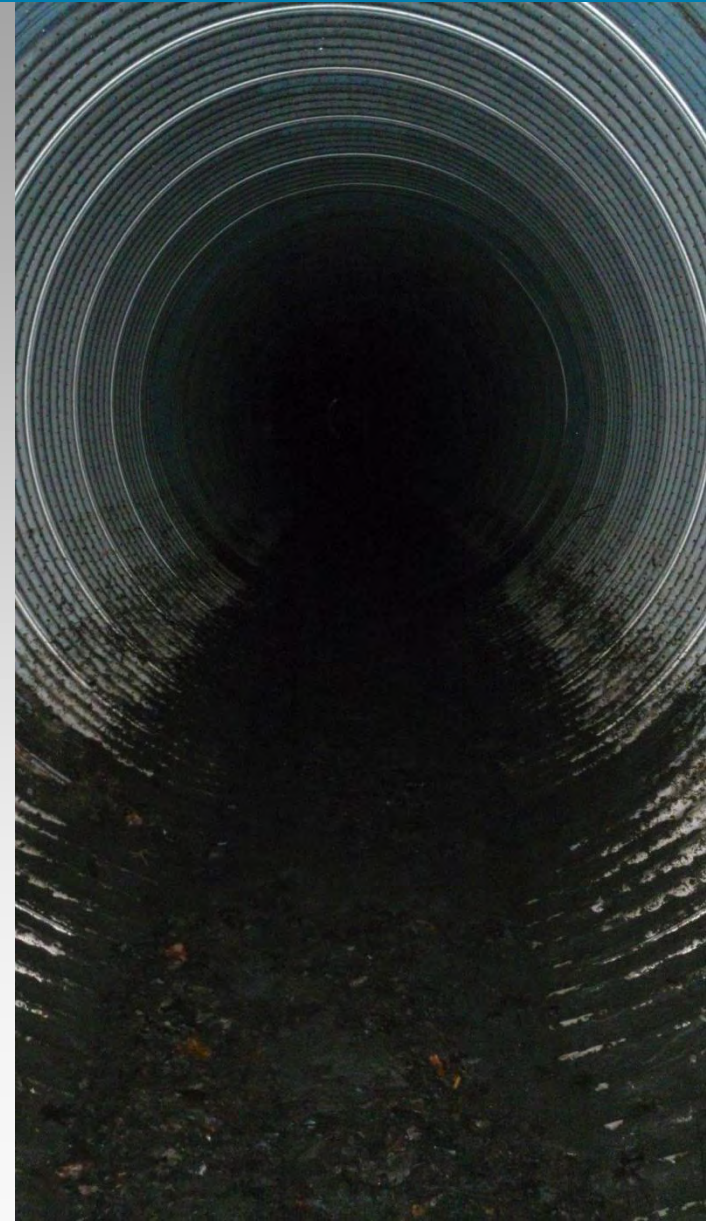
Total Solids Load

- Sum of:
 - Total TSS Load Removed by BMP
 - **Gross Solids** Captured by BMP
 - **Gross Solids** Captured by Pretreatment Units
- * **Gross Solids** are Particles Larger than Suspended Size (Debris Such as Floatables, Organic Matter, and Sediment).
- Gross Solids were **Measured** in Pretreatment Units for Arlington-Hamline Facility and Trenches
- Gross Solids Captured by Rain Gardens and Como Park Regional Pond Were **Estimated**

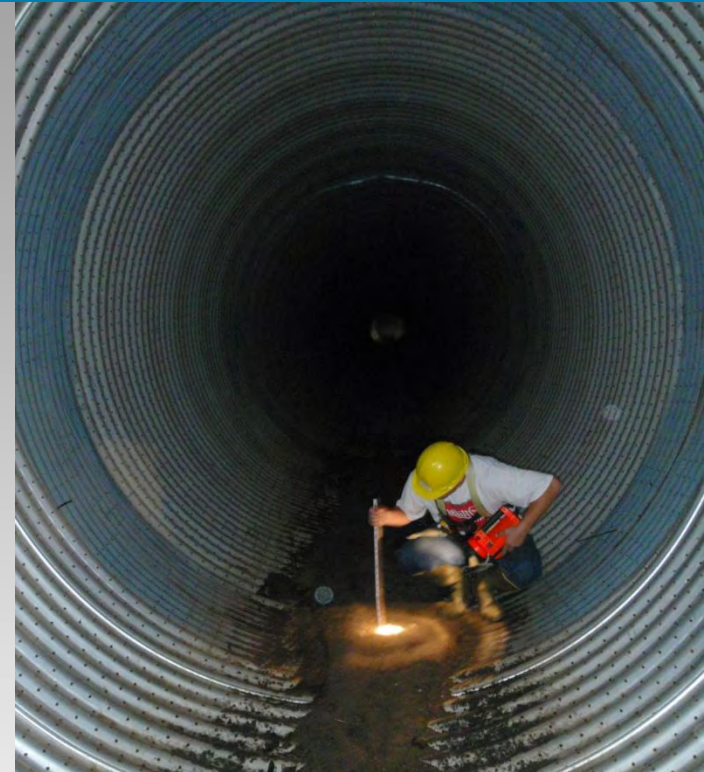
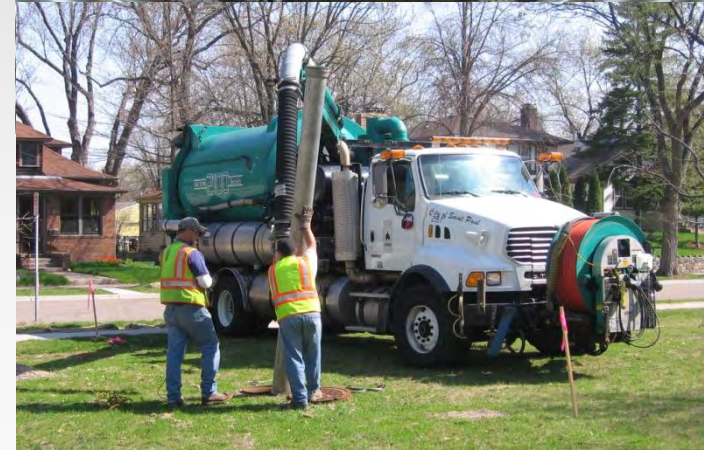
Routine O&M:

Future O&M:

- Debris Removal From Pipe Gallery

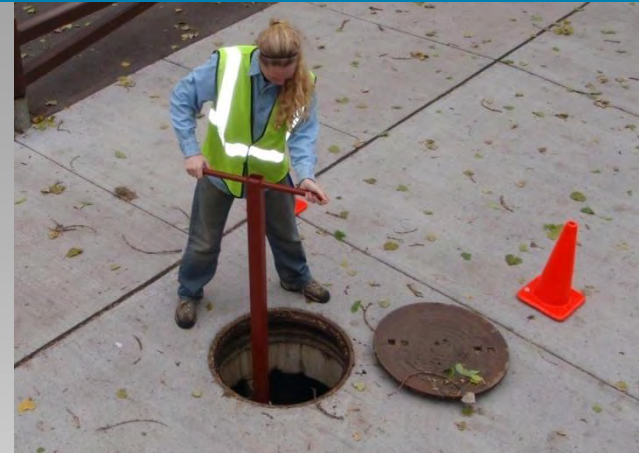
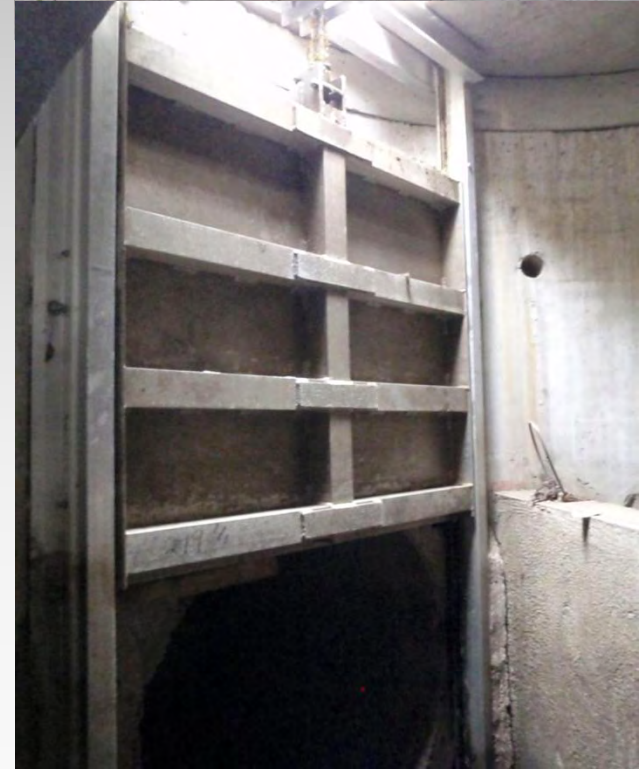
Como Park Regional Pond O&M

Routine O&M:

- Sluice Gate and Gate Valve Maintenance
- Debris Removal From Pond Perimeter and Outlet Structure
 - Completed by City of St. Paul Parks & Rec

Future O&M:

- Bathymetric Survey of Pond
- Debris Removal From Pond (Dredging)

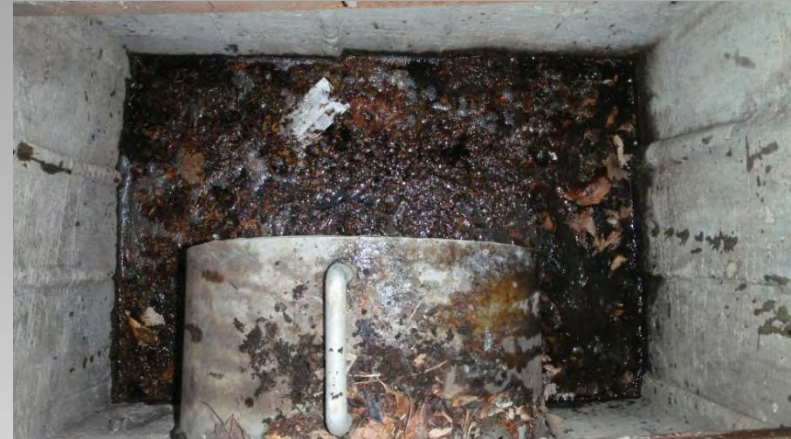
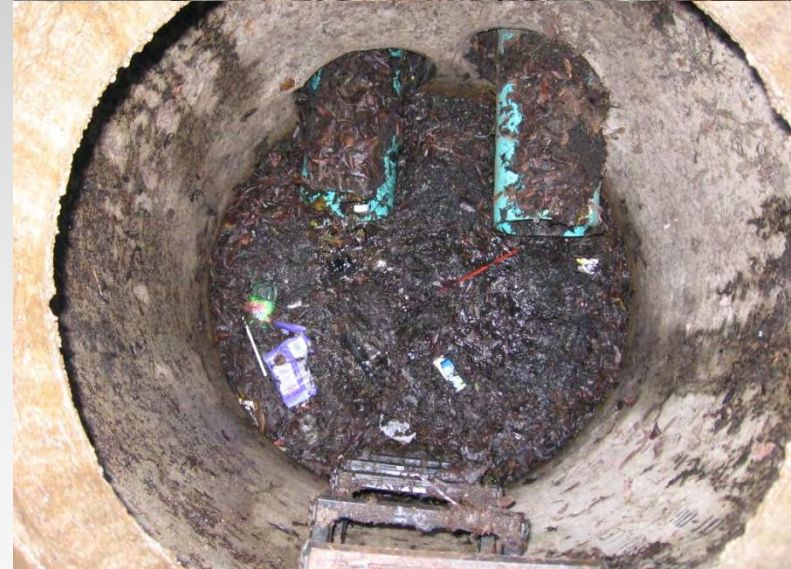
Infiltration Trenches

Routine O&M:

- Manhole and Catch Basin Sediment Inspections
- Post-Rain Trench Infiltration Inspections
- Debris Removal From Sumped Catch Basins and Manholes
- Catch Basin Hood Inspections and Gasket Replacement

Future O&M:

- Jet Out and Remove Debris Accumulated in Perforated Pipes

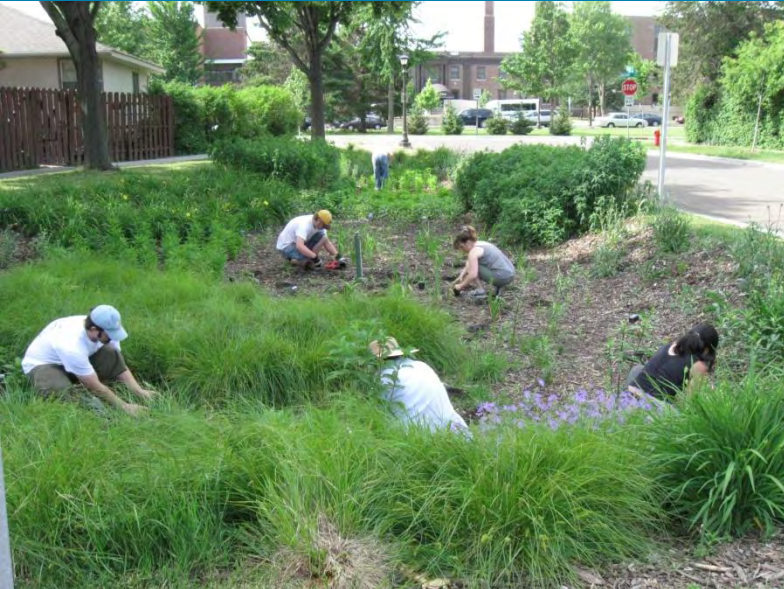
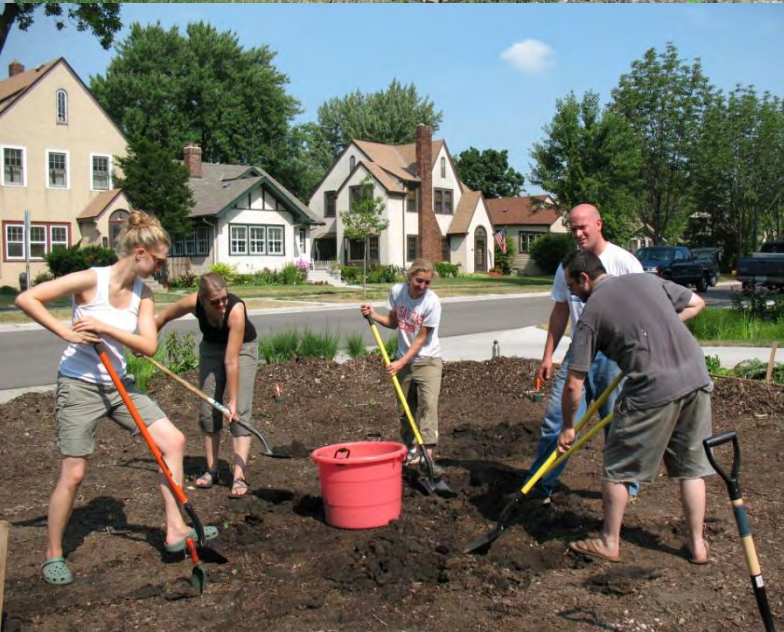
Rain Gardens

Routine O&M:

- Monthly Inspections
- Post-Rain Inspections
- Maintenance
 - Mulching, Weeding, Mowing, Leaf Removal
